Test and Analysis of a Stitched RFI Graphite-Epoxy Panel with a Fuel Access Door

March 1994

TEST AND ANALYSIS OF A STITCHED RFI GRAPHITE-EPOXY PANEL

WITH A FUEL ACCESS DOOR

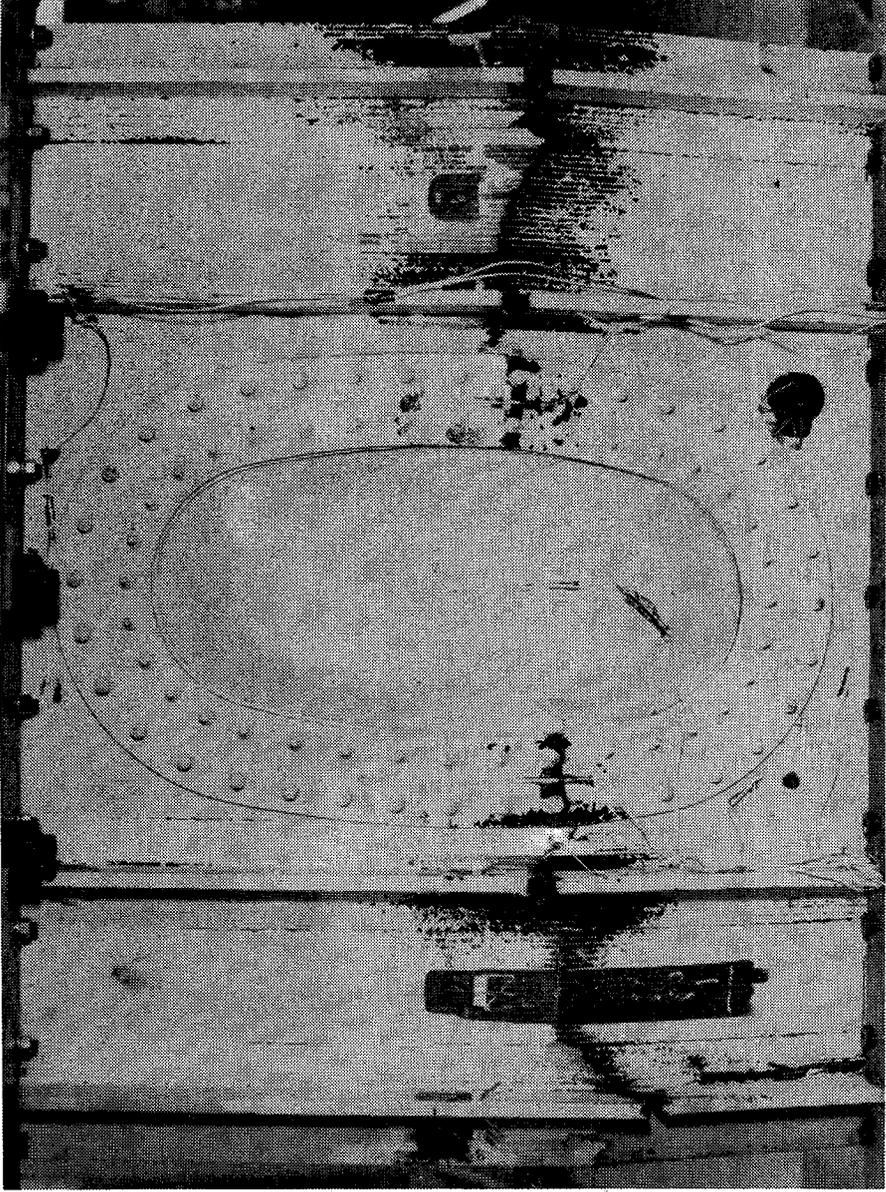
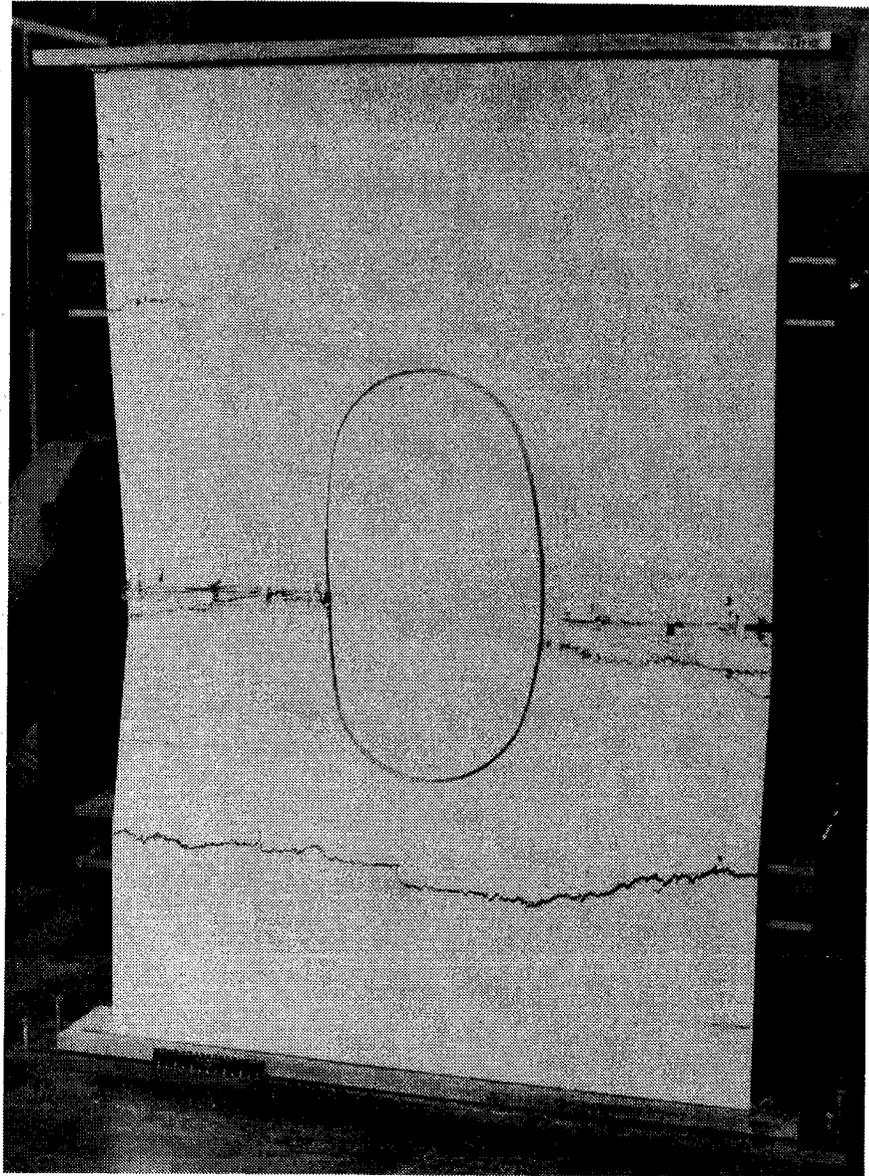
Photographs of the stiffened and unstiffened sides of the panel after failure are shown in figure 25(a) and (b), respectively. Failures near midlength and near the intercostals can be seen. The failures at the intercostals occurred after the midlength failures. All four stringers failed from the top of the blade to the skin, as shown for one of the outermost stringers in figure 25(c). The stitched flanges did not separate from the skin at any location.

In addition, the panel failed at the top and bottom intercostals after the initial failure through the bolt holes and access door. Sections of the intercostals completely separated from the skin and the skin cracked across the entire width at the bottom intercostal and from the edge of the panel to the innermost stringer on each side at the top intercostal. The failures at the bottom intercostal can be seen in figure 25(b).

(a) Stiffened side.

(b) Unstiffened side.

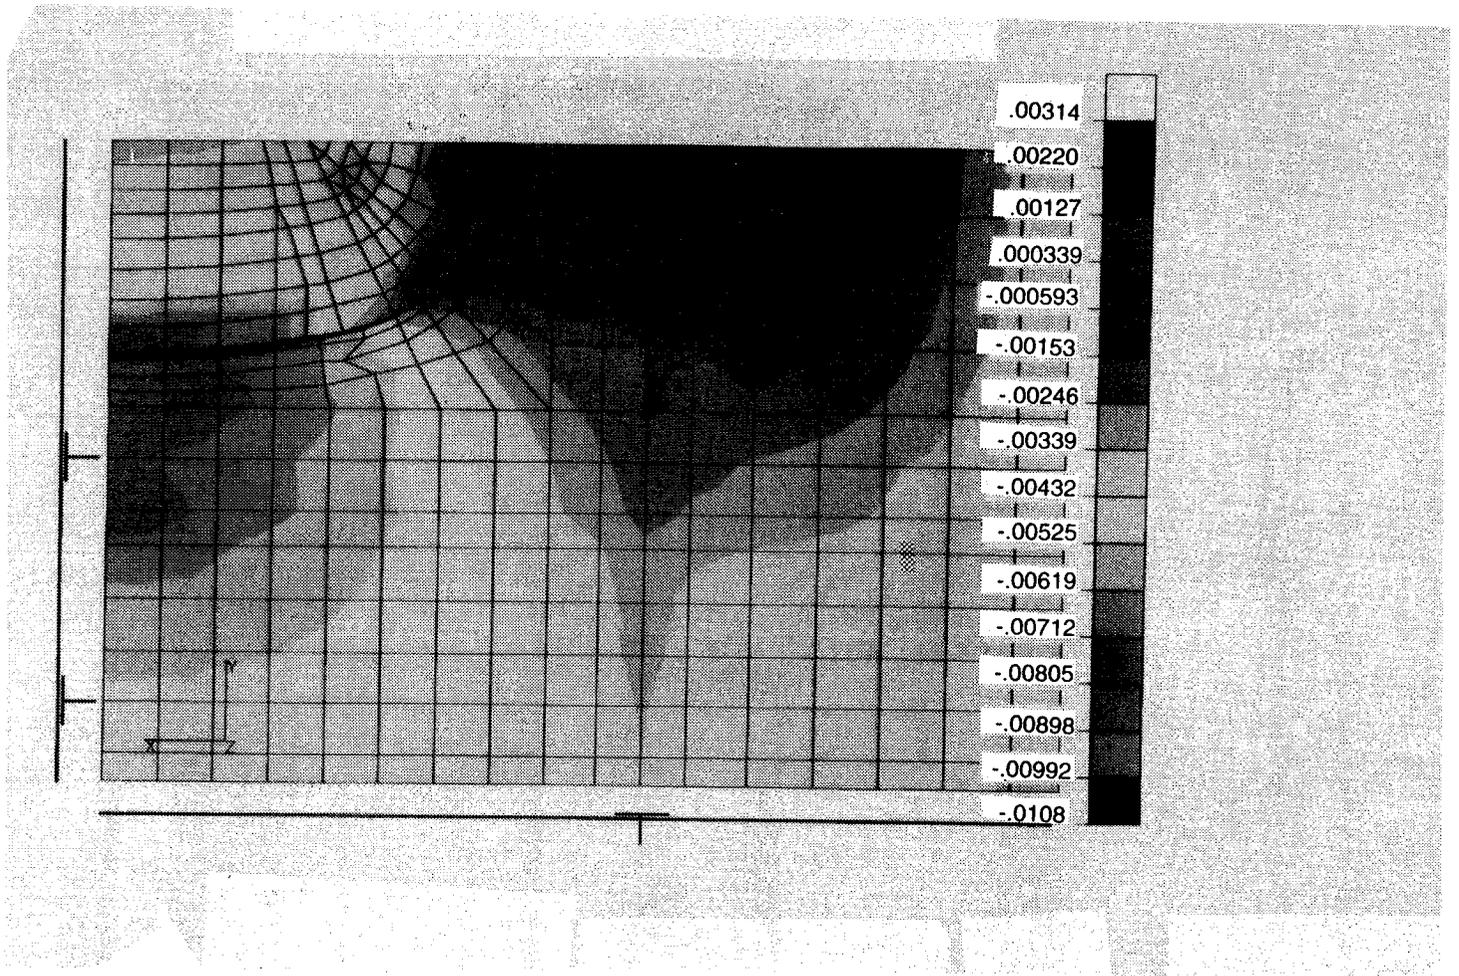
A contour plot of the axial strain predicted by the analysis at a load of 688,160 lb using nonlinear material properties is shown in figure 24. The region of highest axial strain is near midlength and between the innermost stringer and the cutout for the access door.

The panel failed at a load of 695,000 lb in an overall collapse mode. The damage induced at collapse involved initial failures across the width at approximately 2 inches below midlength on the skin on one side of the access door and approximately 3 inches below midlength on the skin on the other side of the door. The failure passes through the bolt holes on both sides of the access door. This region has the highest axial strain, as shown in figure 24.

Figure 24. Contour plot of axial strain at failure load.

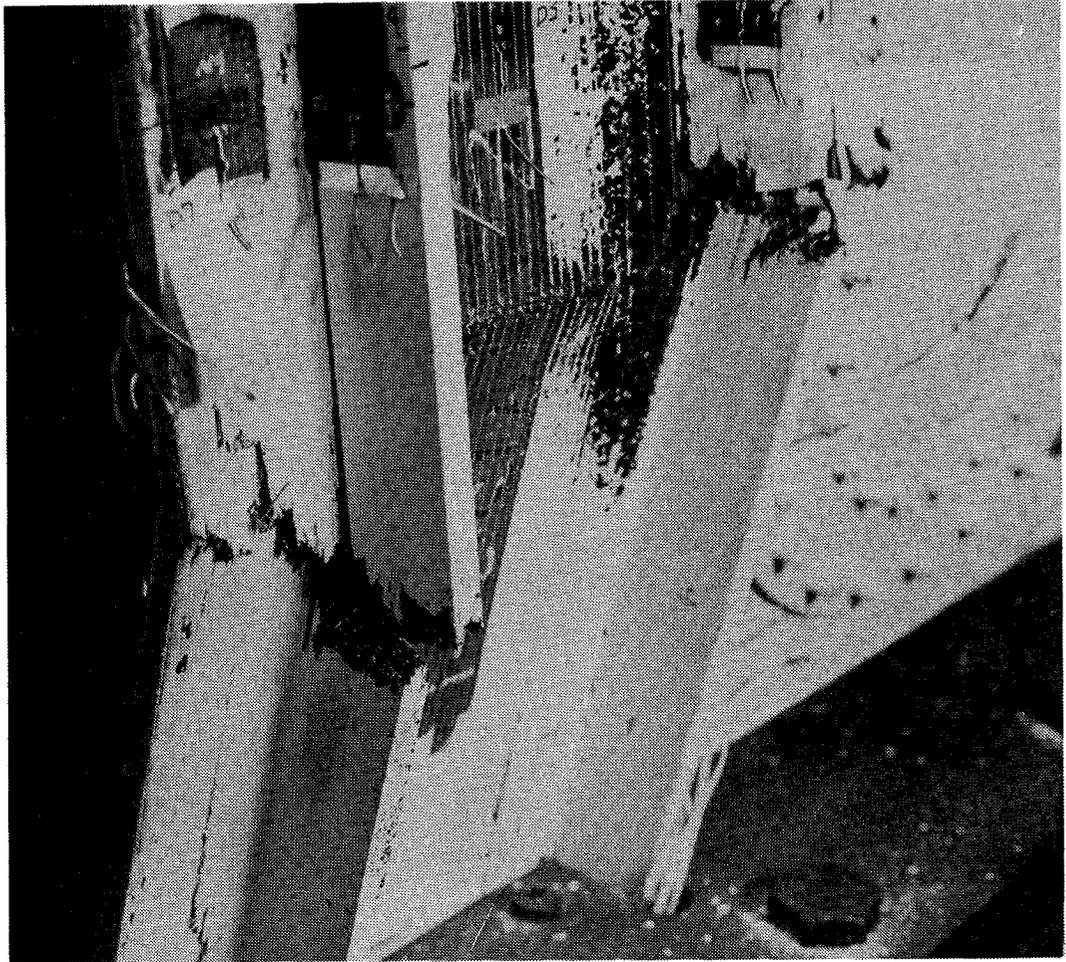
(c) Broken stringers.
Figure 25. Panel after failure.

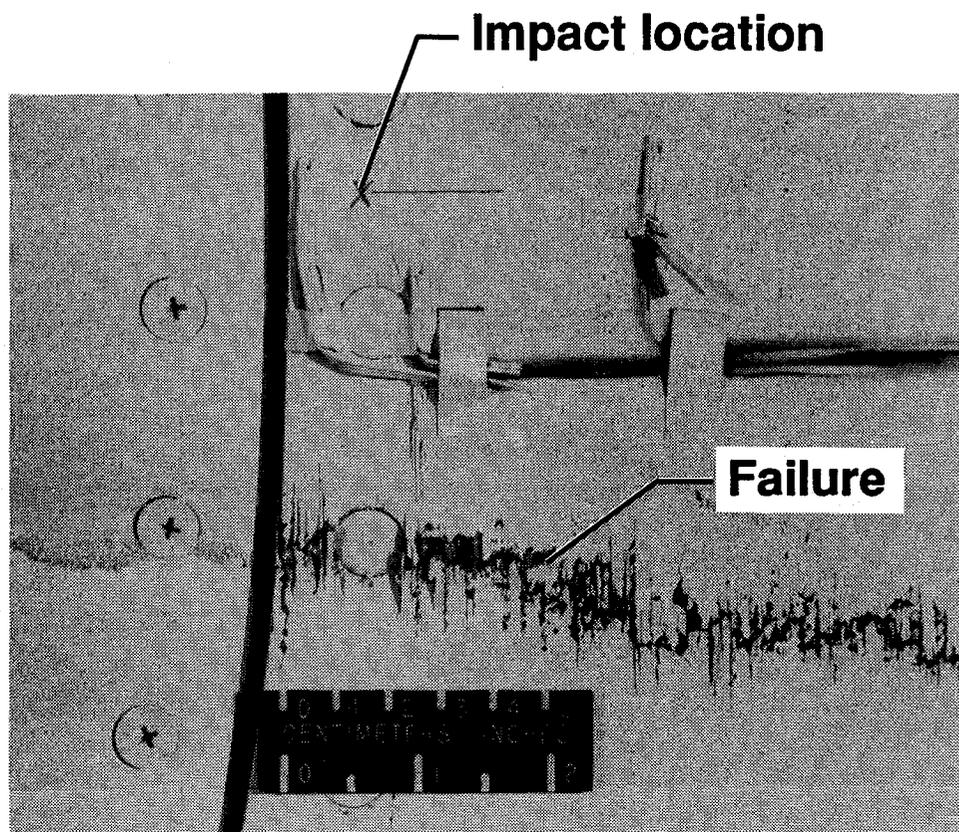
The failure does not pass through the impact site (which is located .75 inches below the midlength location and .5 inches from the edge of the cutout for the door) on either side of the door. Photographs of the failure and impact sites are shown in figure 26.

(b) Right side of door.

Figure 26. Failure and impact-damage locations on either side of access door.
